Client Name:  
NAIFMA Realty

Location:  
Lincoln, Nebraska

## US BANK PARKING GARAGE

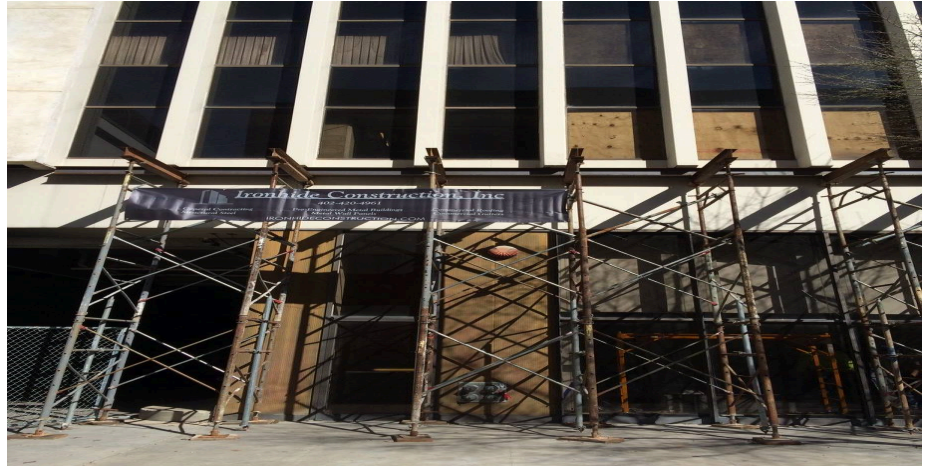
The south precast concrete panel wall of the US Bank parking structure was impacted and began falling off the building. Ironhide Construction was called in to inspect the site. By Noon the next day, the street was shut down, engineers visited and designed a shoring tower to prevent the panels from falling off. The city officials, the Lincoln Fire Department, and Lincoln Police all visited the site in case of catastrophic failure.

Once the temporary support system was installed, Ironhide Construction fabricated and installed an interior structure that reconnected the precast panels to the parking structure, and then we hoisted the precast panels back into their original position. We also needed to use a carbon fiber repair system on a main sprandrel beam that held up the parking structure as it had completely failed and could have fallen.
