Client Name:
NAIFMA Realty

Location:
Lincoln, Nebraska

General Contractor:
Ironhide Construction

US BANK PARKING GARAGE

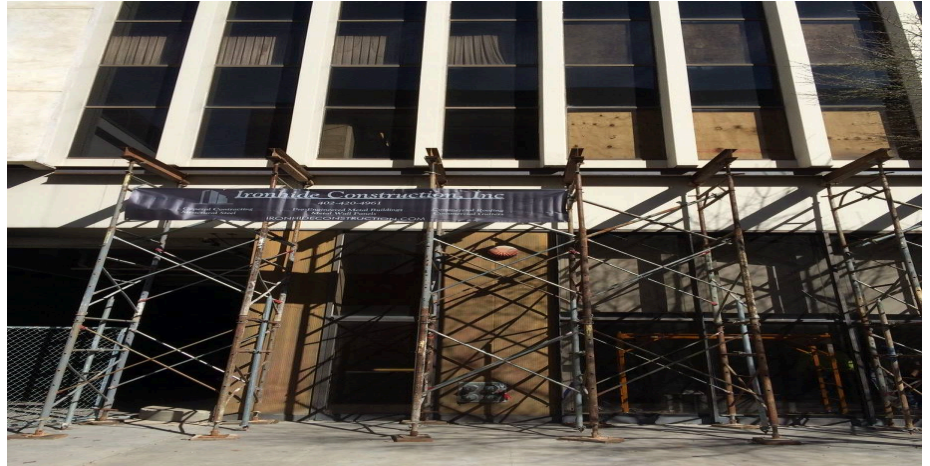
The south precast concrete panel wall of the US Bank parking structure was impacted and began falling off the building. Ironhide Construction was called in to inspect the site. By Noon the next day, the street was shut down, engineers visited and designed a shoring tower to prevent the panels from falling off. The city officials, the Lincoln Fire Department, and Lincoln Police all visited the site in case of catastrophic failure.

Once the temporary support system was installed, Ironhide Construction fabricated and installed an interior structure that reconnected the precast panels to the parking structure, and then we hoisted the precast panels back into their original position. We also needed to use a carbon fiber repair system on a main sprandrel beam that held up the parking structure as it had completely failed and could have fallen.
